Service Information

Model Nakamichi 580, 581, 582
Serial No. from
Subject Countermeasure for Unexpected Shut-Off in Playing or Recording.

No. NR-0036
Date 5/16/79

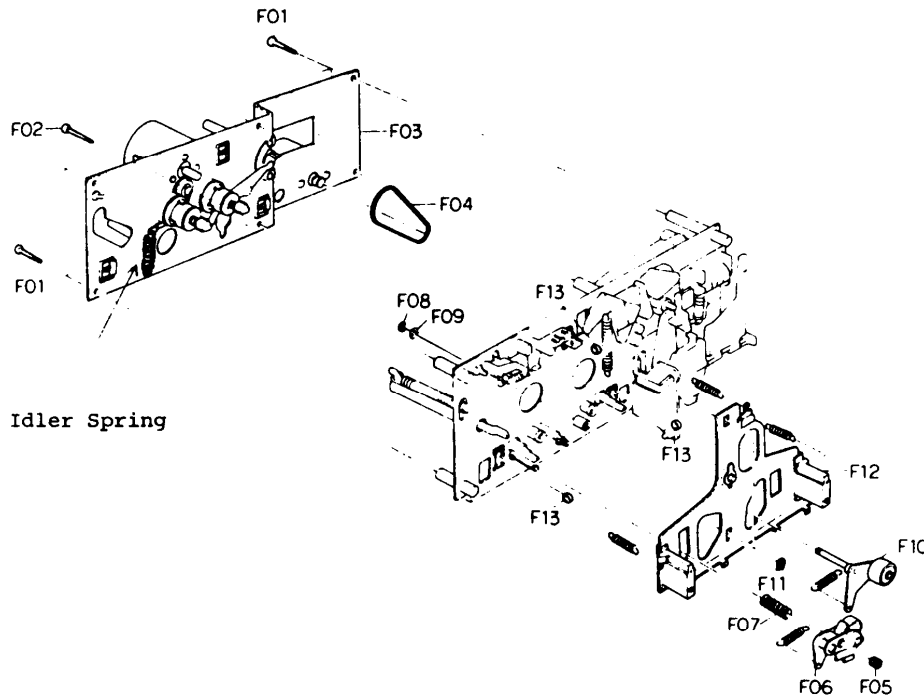
The problem is that after playing or recording for a while, the unit will drop out to the stop mode unexpectedly. When the pressure of the idler pulley on the take-up reel hub is insufficient, it becomes harder to get a constant torque on the take-up reel hub. This creates the possibility of the shut-off problem.

- a) Replace the idler spring from original one (15g) to new one (25g) to make the pressure of the idler pulley on the take-up reel hub stronger.
- b) The part number of this new idler spring is 0C08127B.
- c) Location of the idler spring is shown in the figure below.

- d) Clean the idler pulley and the reel hub after replacing the idler spring so that the energy will be transferred smoothly from the idler pulley to the reel hub.
