NAKAMICHI

Model NAKAMICHI 580, 581, 582
Serial No. from

Subject Countermeasure for Unexpected
Shut-off in Playing or Recording

No. NR-0037 (1/2)
Date 8/20/79

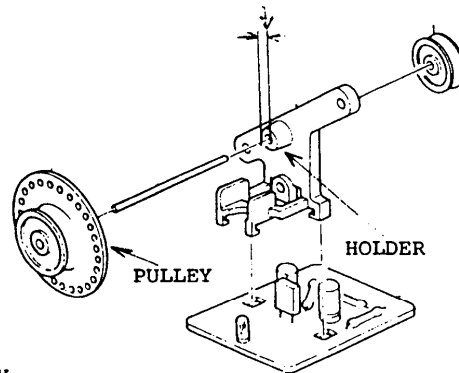
A certain number of the 580 series have the Auto Shut-off Ass'y in which the Shut-off pulleys have been assembled too tightly. These pulleys rotate hardly in playing or recording, and this causes the shut-off problem.

There should be 0.3mm-0.5mm gap between PULLEY and HOLDER.

This service information will show how to readjust these pulleys' condition. There should be 0.3mm - 0.5mm gap between the pulley and the holder so that they can rotate smoothly.
