Service Information

Countermeasure for Breakage of Eject

Subject Linkage Holder in Mechanism Ass'y

No. OOD-SI-3115 (1/2)
Date 10 November 1988

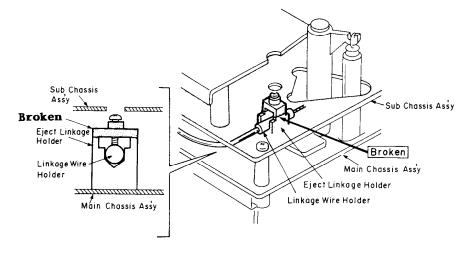
Fig. 1

This Service Information is prepared to give information how to repair when molded upper part of the Eject Linkage Holder is broken as shown in Fig. 1. As the Eject Linkage Holder fixes the Linkage Wire Holder, breakage of that part causes eject operation of the cassette compartment to be inoperative.

If above breakage occurred in the Mechanism Ass'y, please repair it referring to "3. Replacing Procedures". For repair, however, a special parts kit is required.

- (1) Remove the Mechanism Ass'y.
- (2) Remove the broken part of the Eject Linkage Holder (shaded part on the left side of Fig. 1).
