## Service Information

Subject Elimination of Squeaking Noise

No. NR-0040  
Date 2/16/82

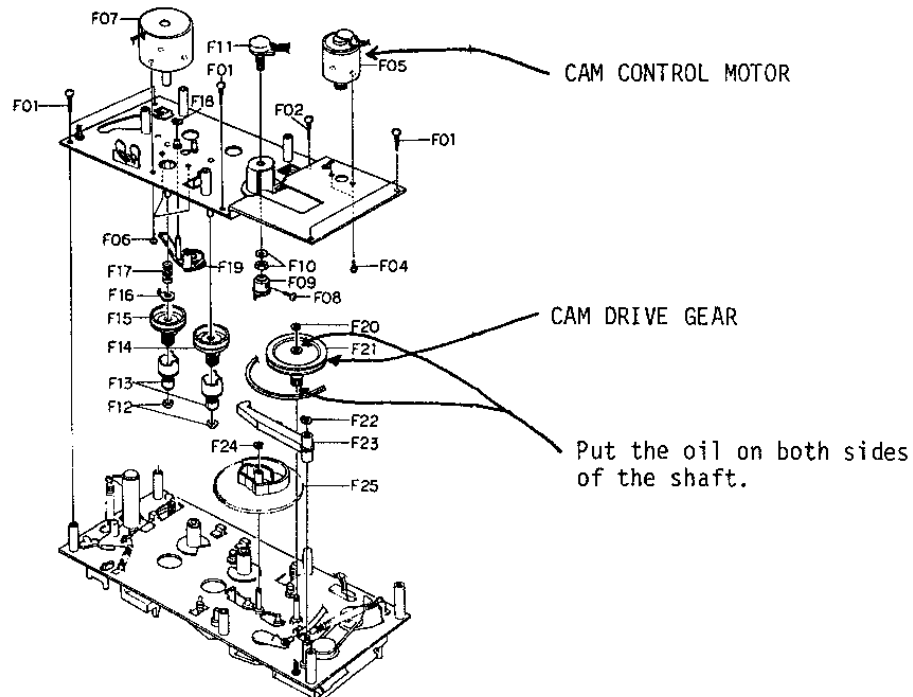
When unexpected mechanical squeaking (scraping) noise is found when engaging in the stop mode in the Nakamichi Standard Mechanism of any model, the following procedure should be tried to eliminate it unless any other specific cause can be pointed out.

1. Remove the Top Cover.
2. Locate the Cam Drive Gear (OC08186A) indicated in the figure of the mechanism.  
\*This gear is directly driven by the cam control motor through the rubber belt.
3. Put a little drop of oil onto the shaft of the Cam Drive Gear.  
\*Use high quality oil. (Clock oil, etc.)  
\*Put the oil on both sides of the shaft as indicated in the figure.  
\*Do not use too much oil.
4. Engage the play and stop mode repeatedly and make sure that the gear will move without making any noise.
